# GHD Report for City of San Leandro San Leandro Marina

## Marina Facilities Decommissioning Assessment

March 2018

**GHD** | 5900 Hollis Street, Emeryville, CA 94608  
11119148 | Report No 6 | March 12, 2018

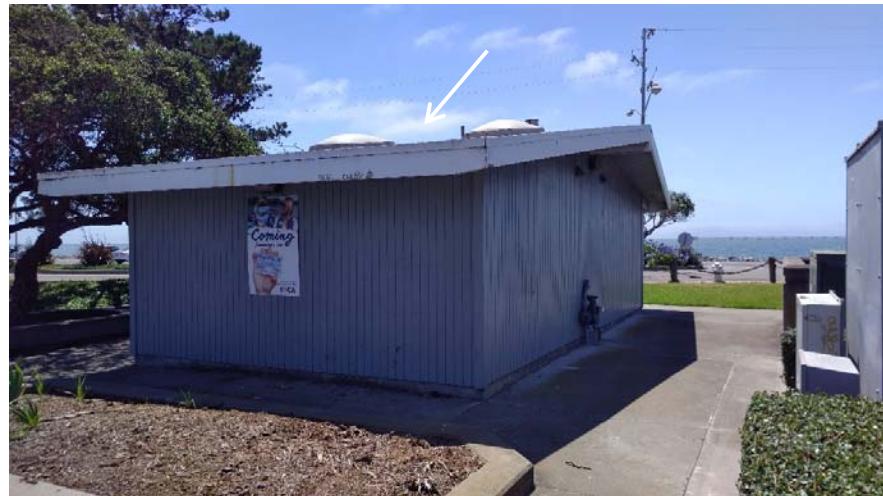
**Photograph 1** – Marina – Restroom A, B – Roof penetrations – Penetrations throughout (indicated by white arrow) reported to contain asbestos.

GHD recommends that materials reported to contain detectable concentrations of asbestos (Category I and II ACM, RACM, ACCM and/or Presumed ACM) should be removed by a licensed abatement contractor as described further in this report.

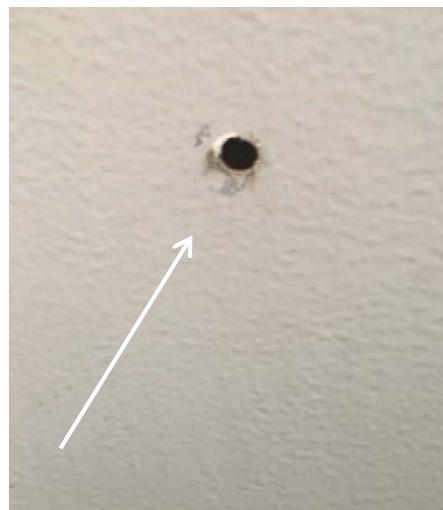
**Photograph 2** – Marina – Restroom E, F – Wall texture (white) – Sampled at wall systems (indicated by white arrow) reported to contain asbestos.

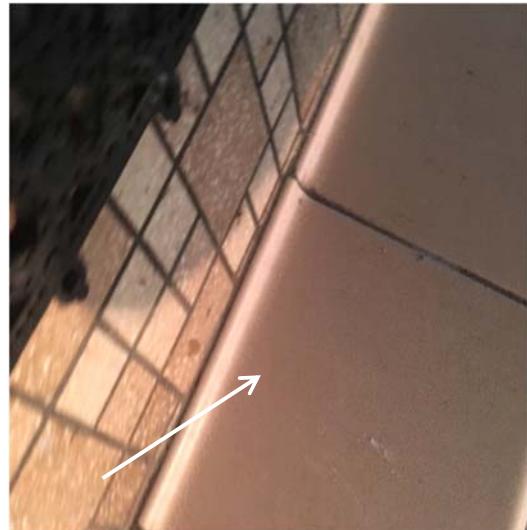
**Photograph 3** – Marina – Restrooms E interior – Ceramic tile mastic (tan) located underneath tile - associated with floor and wall systems (indicated by white arrow) reported to contain asbestos.

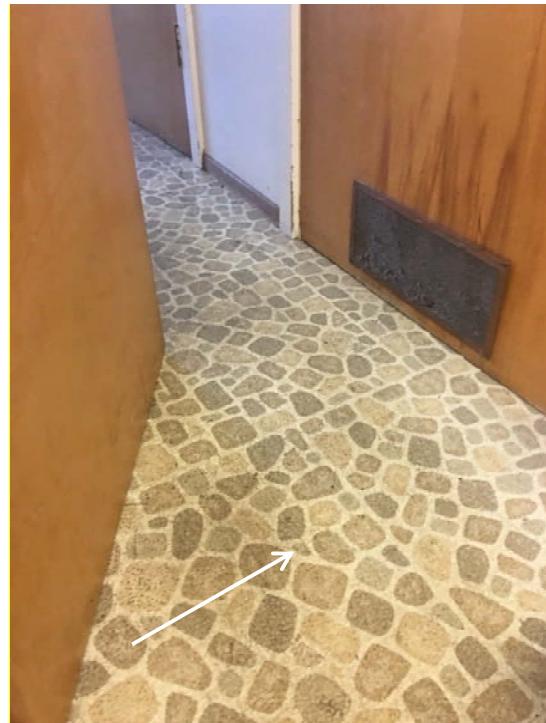
**Photograph 4** – Marina – Harbor Master’s Office – Resilient sheet flooring (tan/gold), 12"x12" vinyl floor tile (not shown, located underneath RSF) (indicated by white arrow) both reported to contain asbestos.

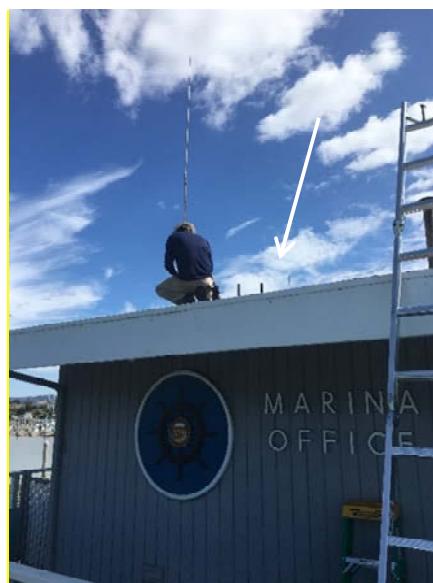
**Photograph 5** – Marina – Harbor Master’s Office – Roof – Roof Penetrations throughout (grey and black) (typical, indicated by white arrow) reported to contain asbestos.

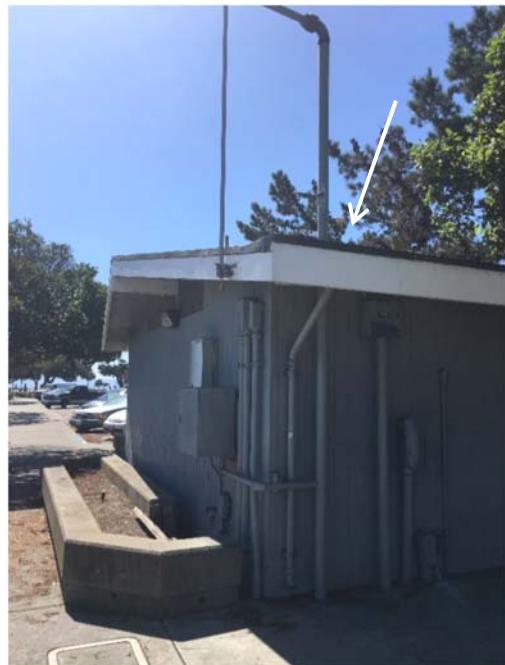
**Photograph 6** – Marina – Restroom F – Roof – Roof Caulk (white/grey) (typical, indicated by white arrow) at penetrations throughout reported to contain asbestos.

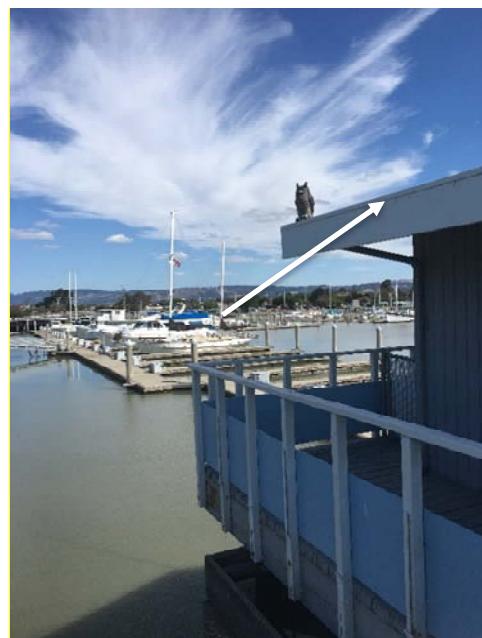
**Photograph 7** – Marina – Harbor Master's Office – Flashing and sealant (grey) (typical, indicated by white arrow) and reported contain asbestos.

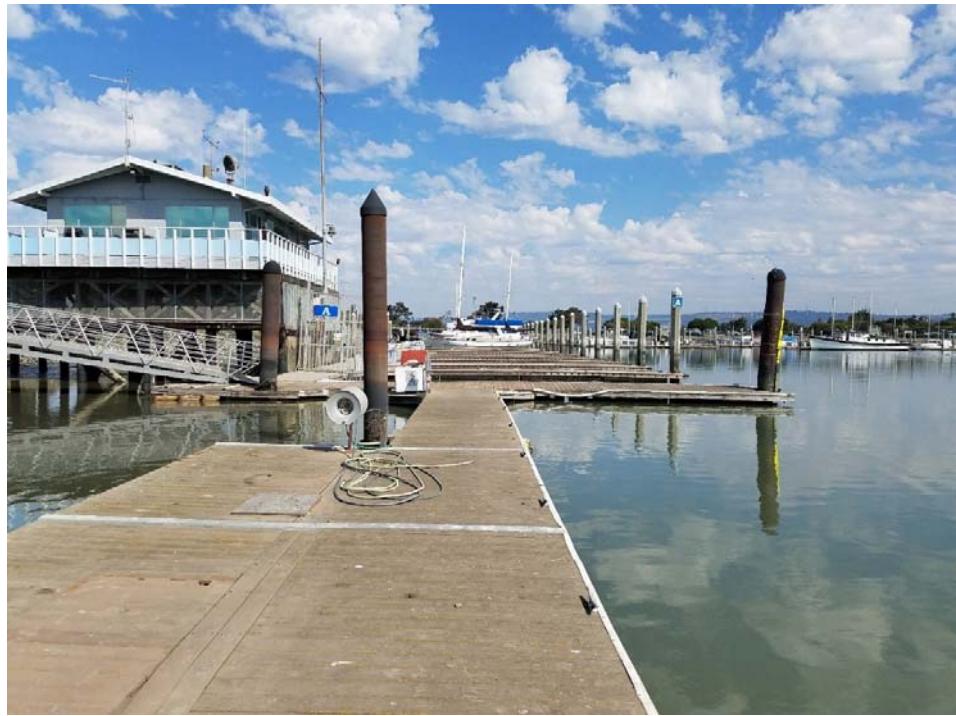
The floating docks just south of Pier A was originally the refueling dock that has been decommissioned. It was constructed of approximately 1,760 square feet of plastic lumber but is in poor condition and does not appear to be salvageable. There is a significant and noticeable deflection and rebound while walking on the refueling dock.

There are four steel guide piles at the old refueling dock and they appear to be in good condition without any noticeable corrosion or section loss. These piles are expected to be fairly straightforward to remove in one piece, and are valuable as scrap metal.

Photo 1 - Plastic lumber refueling dock with steel guide pile

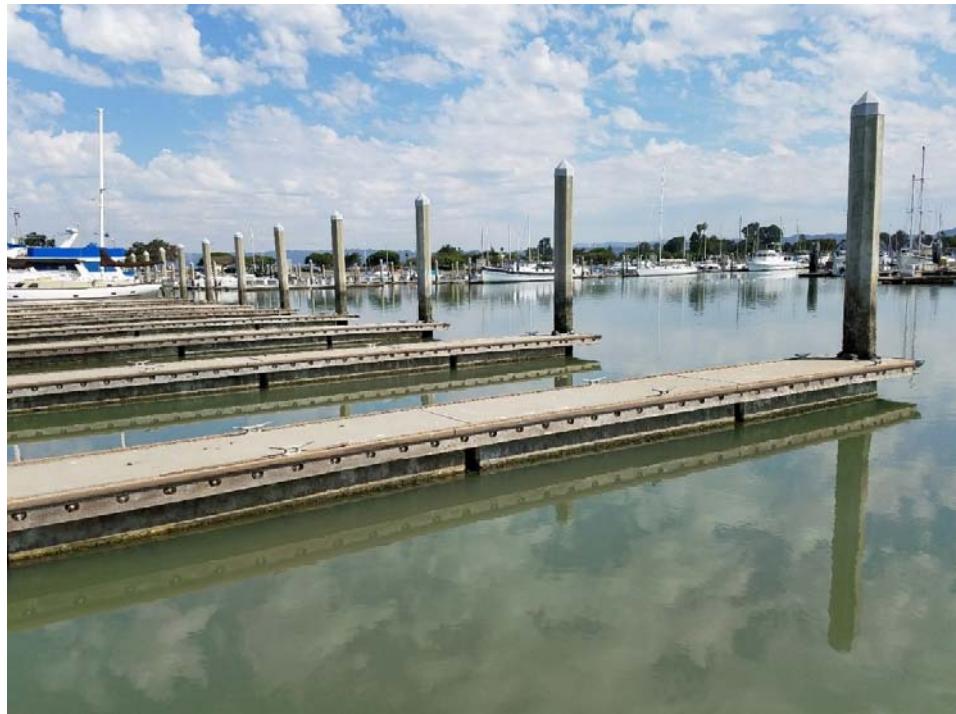
Piers A through H were renovated in 1990 where existing timber floating docks were removed and replaced with new concrete floating docks. There are approximately 58,520 square feet of concrete floats and fingers, and are generally in good working condition and salvageable.

Photo 2 - Pier A -- Typical Concrete Float Condition

The concrete and timber floats are disconnected from the guide piles and broken into smaller sections. Using a barge-mounted crane, the timber floats can be loaded for offsite recycling or disposal, and the concrete floats can be salvaged.

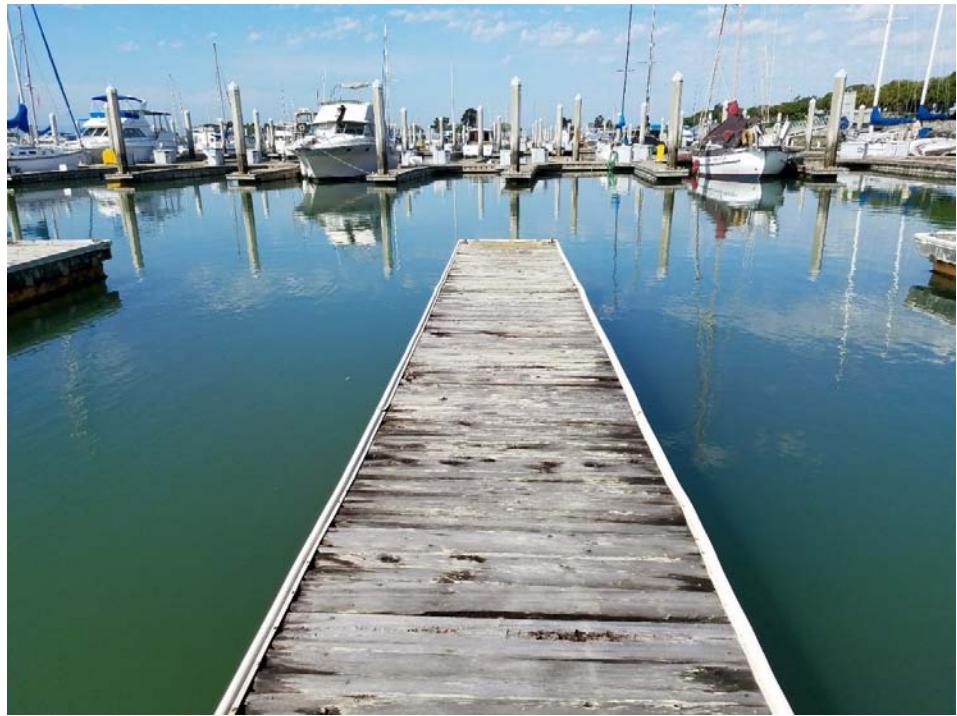
The remaining Piers J through Q consist of timber floating docks and fingers. There are approximately 48,700 square feet of timber floating docks and generally are in poor condition. Piers P and Q were considered unsafe and are currently closed to the public. While the remaining timber docks are in use, they do not appear to be salvageable.

Photo 3 - Typical Condition of Timber Finger

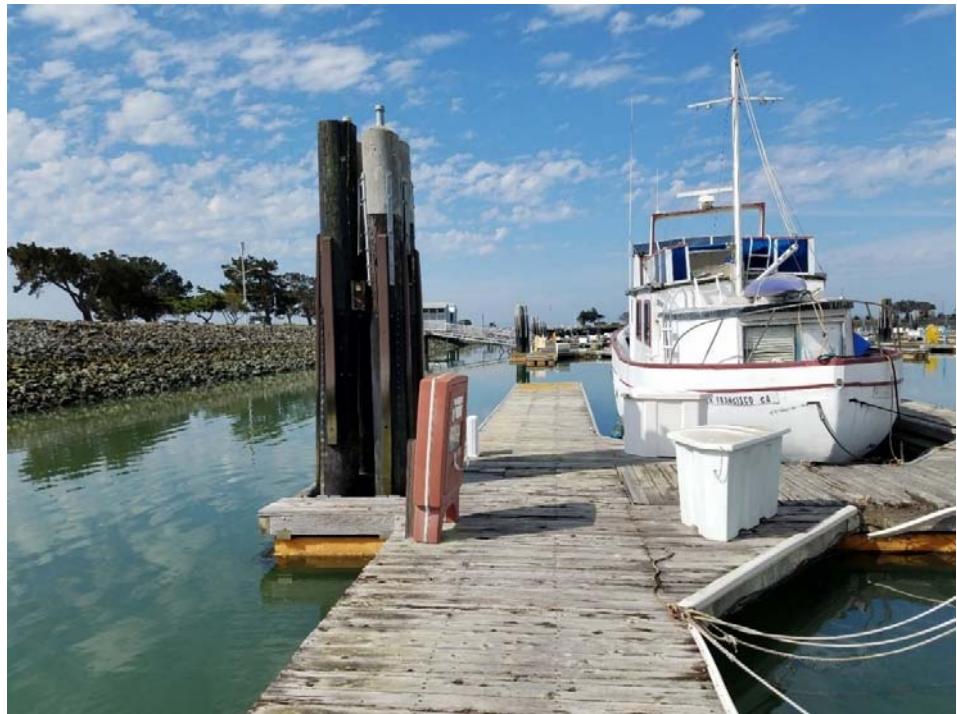
At the remaining Piers J through Q, instead of individual guide piles, four timber piles were bundled together to form a single structure (dolphin) to secure the docks. Many piles appear to have been repaired in the past, such as fiberglass jackets to prevent further section loss, or new steel or concrete caps to restore the upper portion of the timber piles. Per the as-built drawings, the dolphins are 16 inches in diameter and 50 feet long, and comprised of 112 individual piles.

Photo 4 - Typical timber dolphin and floating dock. Note fiberglass jacket and concrete cap on the piles.

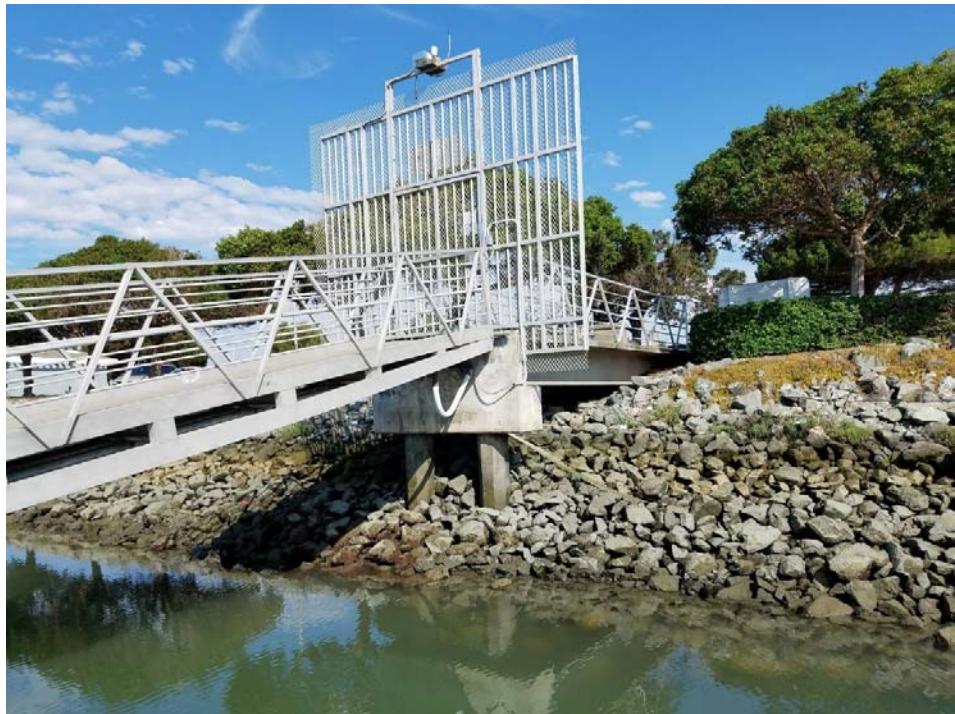
All ten gangways were replaced during the 1990 renovation and are 38-feet long aluminum structures. They appear to be in serviceable condition and without any noticeable deterioration or corrosion.

Photo 5 - Concrete Access Pier and Aluminum Gangway

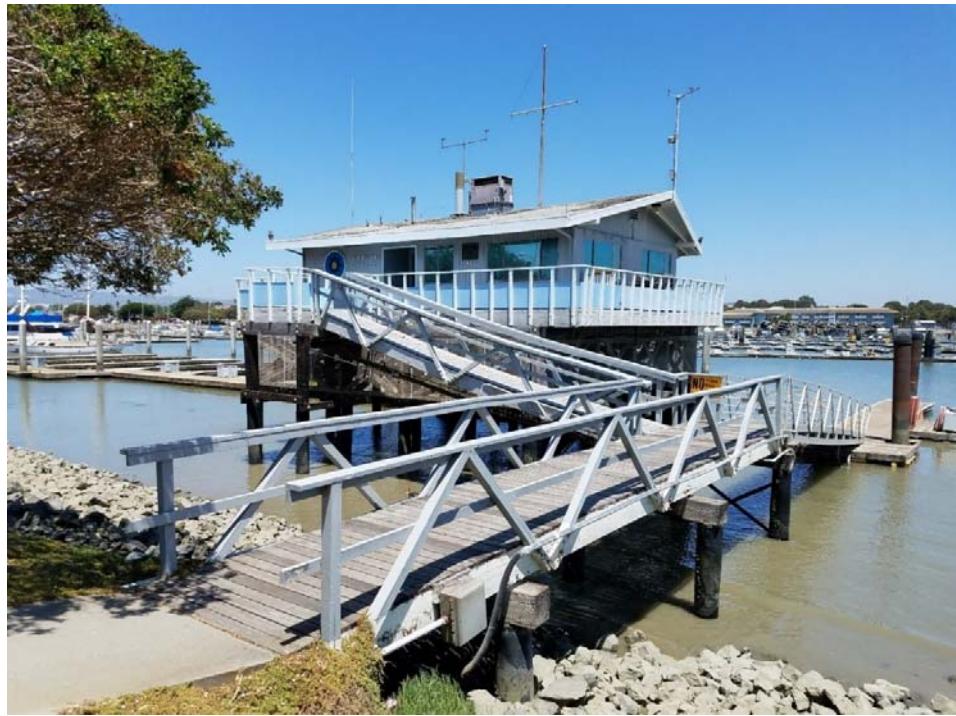
Sample PAINT-HM-1, collected from an exterior wall of the Harbor Master's office, also had an elevated concentration of lead (850 mg/kg). While this concentration is not above the DTSC Hazardous Waste threshold it could be representative of paint that was once primarily lead-based but was subsequently painted over.

Photo 7 - Harbor Master's Office and timber access ramp

GHD recommends that all painted wood removed from the Harbor Master's office, including the raised walkway between the parking lot and the main building, be disposed of as hazardous waste at an appropriately permitted disposal facility.

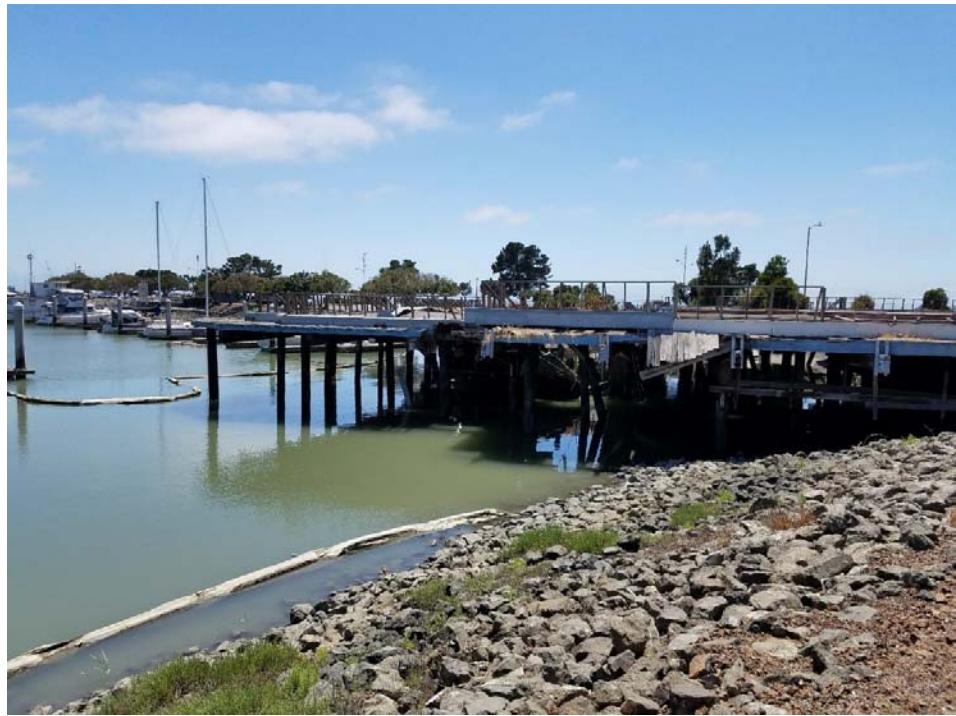
North of Pier A is what remains of the Blue Dolphin Restaurant. The previous building owner closed his business and left the building to rot and all that remains are the piles and pile-supported foundation. Due to the highly deteriorated state, it was not safe to inspect or quantify the piles.

The timber piles are not anticipated to be salvageable and due to deterioration it may be difficult to completely remove the piles without damage.

Photo 9 - Blue Dolphin Restaurant Foundation

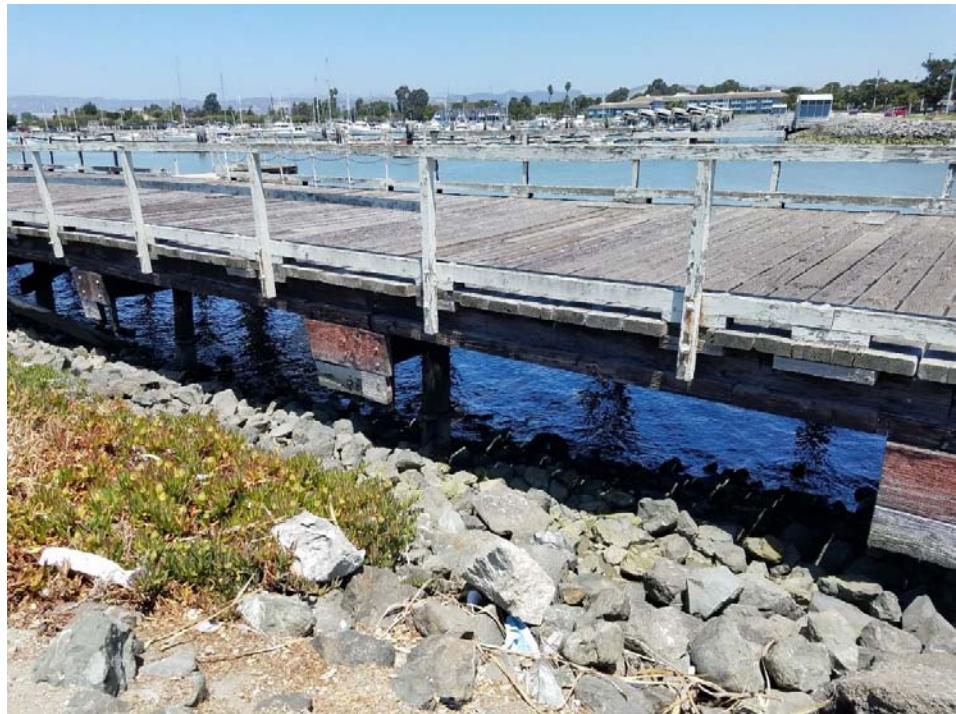
In addition, there are a two other structures supported by piles over the water, namely the Blue Dolphin Restaurant and a former observation deck (now closed), located north and south of Pier A, respectively. The observation deck was heavily damaged by fire, with only the foundation and piles still remaining.

Photo 10 - Closed Observation Deck

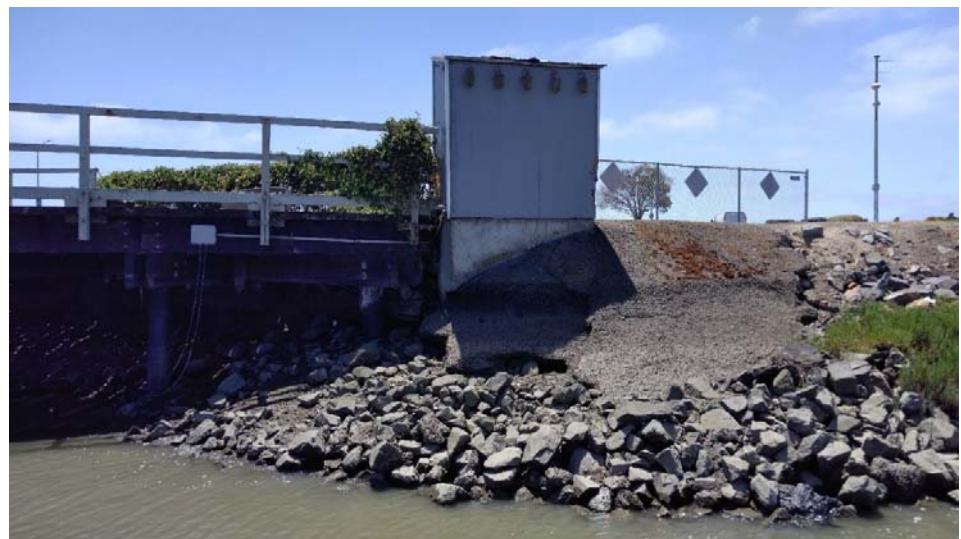
The refueling dock has been served by an on-shore plywood shed (approximately 6'L x 4'W x 8'H) containing electrical panels and pump controllers for pumps and tanks that no longer exist. The entire shed will be demolished to its foundation. The demolition shall include the removal of electrical panels, switches, light fixtures, controllers, and other related appurtenances, including the conduit and conductors attached to the outside and underside of the pile-supported deck.

Photo 14 - Plywood Shed and Pile-Supported Closed Observation Deck
