# GHD Report for **City of San Leandro** **San Leandro Marina**

## Marina Facilities Decommissioning Assessment

March 2018

**GHD** | 5900 Hollis Street, Emeryville, CA 94608  
11119148 | Report No 6 | March 12, 2018

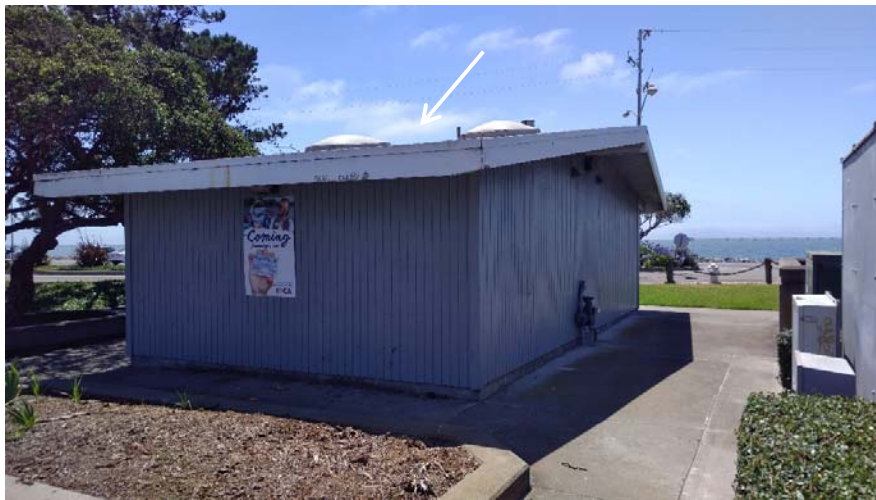
**Photograph 1** – Marina – Restroom A, B – Roof penetrations – Penetrations throughout (indicated by white arrow) reported to contain asbestos.

GHD recommends that asbestos materials be appropriately removed by a licensed abatement contractor prior to the commencement of any renovation or demolition work at the project site. GHD recommends that interior work affecting asbestos-containing materials (ACM) or asbestos-containing construction material (ACCM) (other than thermal system insulation (TSI) and surfacing material) be performed using Class II protocols within sealed, negatively pressurized containments. Exterior work affecting ACM or ACCM (other than TSI and surfacing material) should be performed using, at minimum, Class II work protocols such as wetting down materials after removal. Surfacing material and TSI should be removed using Cal/OSHA Class I work protocols, regardless of the work location.

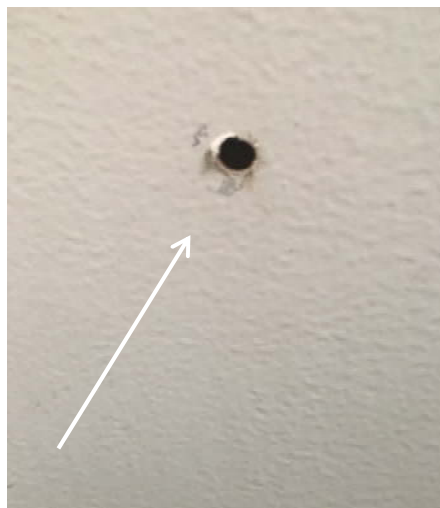
**Photograph 2** – Marina – Restroom E, F – Wall texture (white) – Sampled at wall systems (indicated by white arrow) reported to contain asbestos.

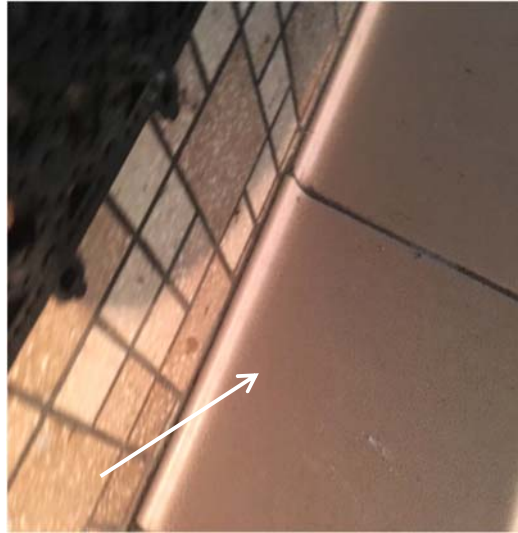
**Photograph 3** – Marina – Restrooms E interior – Ceramic tile mastic (tan) located underneath tile - associated with floor and wall systems (indicated by white arrow) reported to contain asbestos.

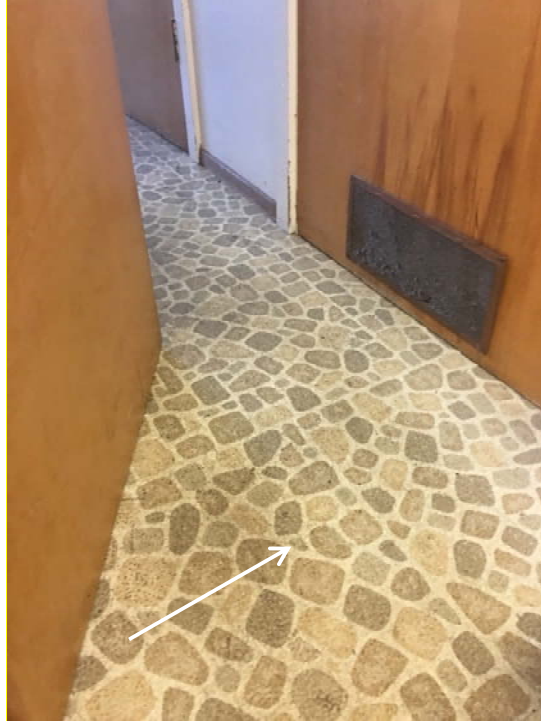
**Photograph 4** – Marina – Harbor Master’s Office – Resilient sheet flooring (tan/gold), 12”x12” vinyl floor tile (not shown, located underneath RSF) (indicated by white arrow) both reported to contain asbestos.

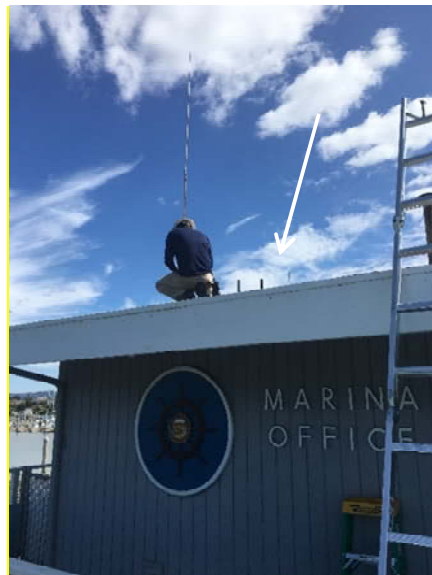
**Photograph 5** – Marina – Harbor Master’s Office – Roof – Roof Penetrations throughout (grey and black) (typical, indicated by white arrow) reported to contain asbestos.

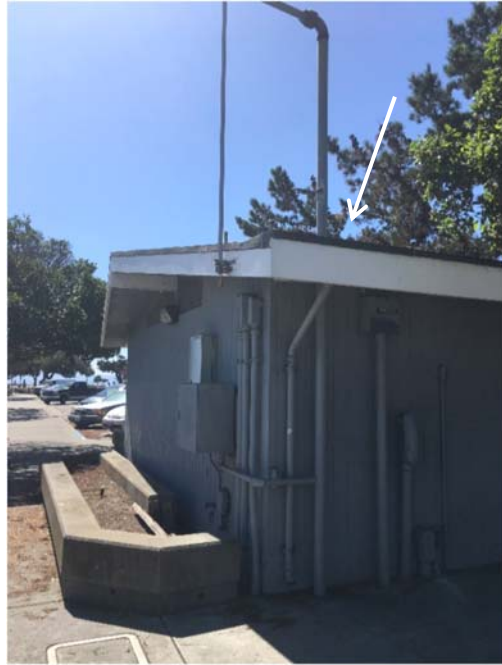
**Photograph 6** – Marina – Restroom F – Roof – Roof Caulk (white/grey) (typical, indicated by white arrow) at penetrations throughout reported to contain asbestos.

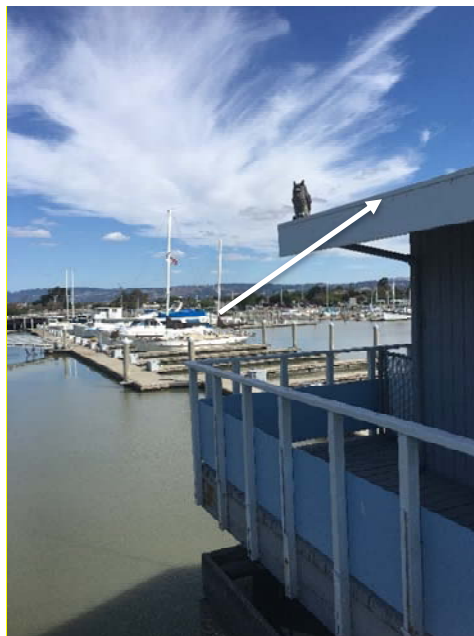
**Photograph 7** – Marina – Harbor Master’s Office – Flashing and sealant (grey) (typical, indicated by white arrow) and reported contain asbestos.

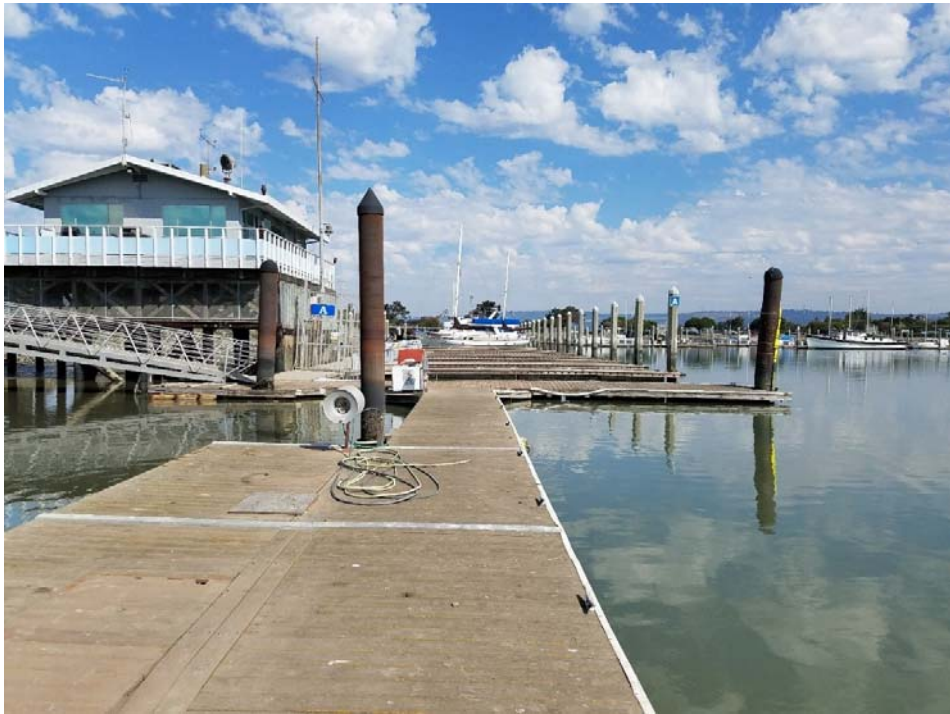
The floating docks just south of Pier A was originally the refueling dock that has been decommissioned. It was constructed of approximately 1,760 square feet of plastic lumber but is in poor condition and does not appear to be salvageable. There is a significant and noticeable deflection and rebound while walking on the refueling dock.

There are four steel guide piles at the old refueling dock and they appear to be in good condition without any noticeable corrosion or section loss. These piles are expected to be fairly straightforward to remove in one piece, and are valuable as scrap metal.

Photo 1 - Plastic lumber refueling dock with steel guide pile

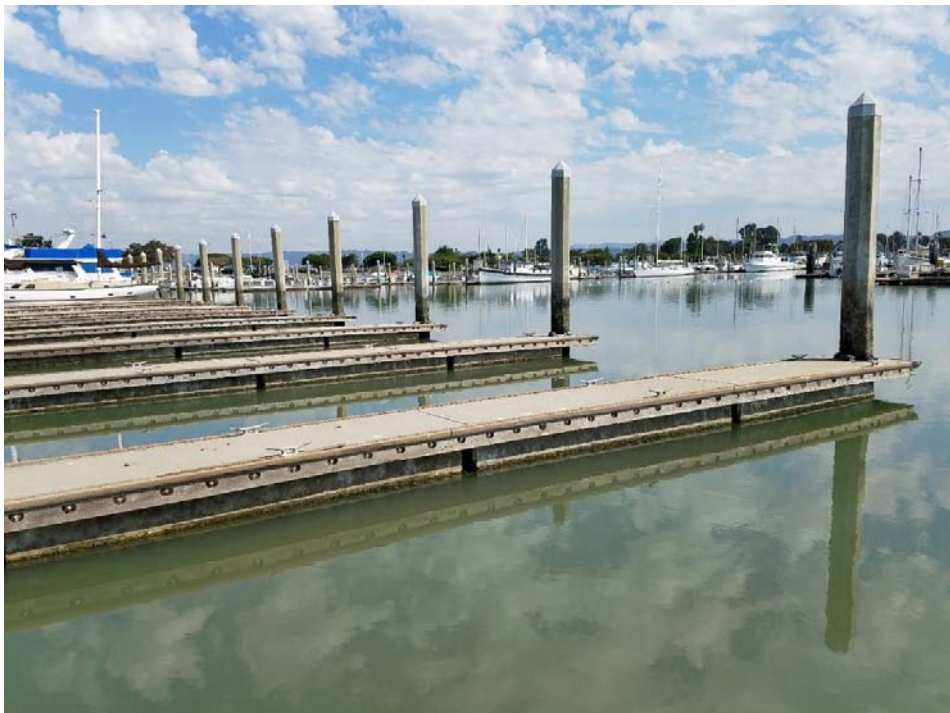
Piers A through H were renovated in 1990 where existing timber floating docks were removed and replaced with new concrete floating docks. There are approximately 58,520 square feet of concrete floats and fingers, and are generally in good working condition and salvageable.

Photo 2 - Pier A -- Typical Concrete Float Condition

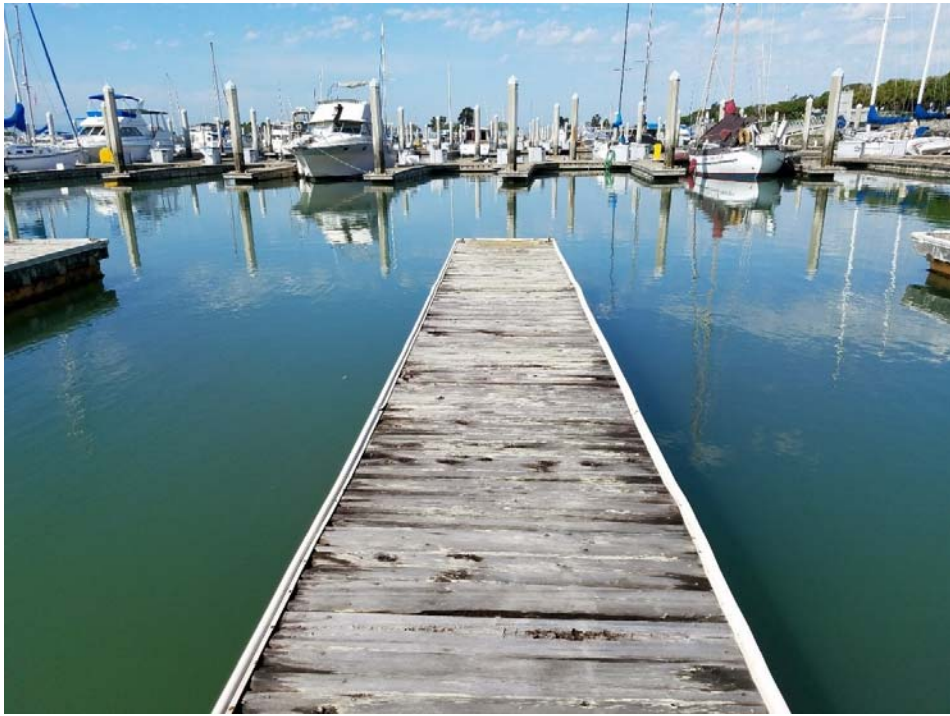
The remaining Piers J through Q consist of timber floating docks and fingers. There are approximately 48,700 square feet of timber floating docks and generally are in poor condition. Piers P and Q were considered unsafe and are currently closed to the public. While the remaining timber docks are in use, they do not appear to be salvageable.

Photo 3 - Typical Condition of Timber Finger

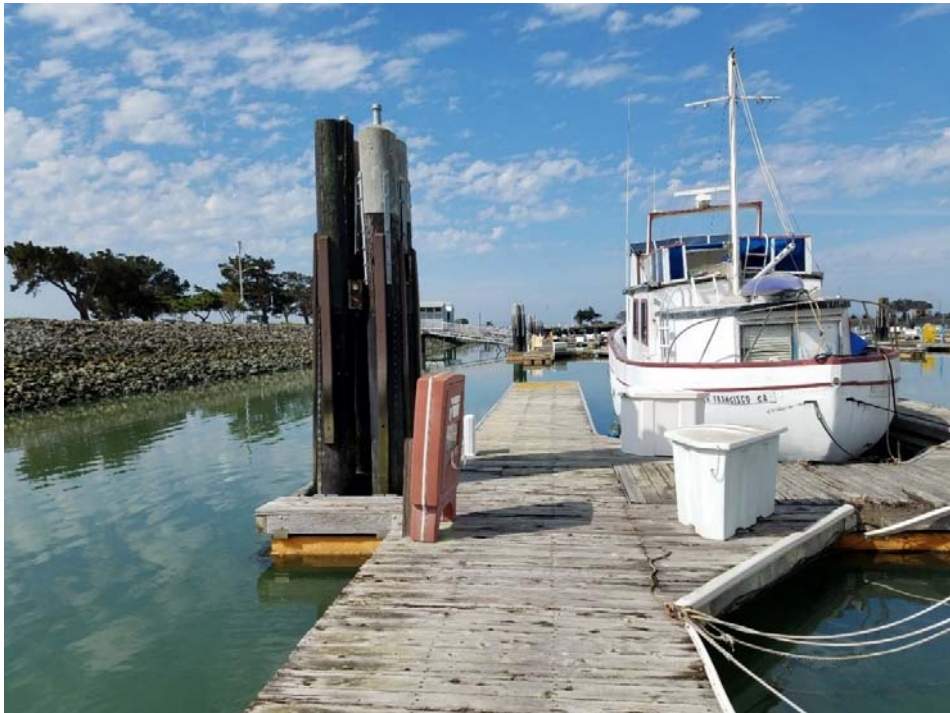
At the remaining Piers J through Q, instead of individual guide piles, four timber piles were bundled together to form a single structure (dolphin) to secure the docks. Many piles appear to have been repaired in the past, such as fiberglass jackets to prevent further section loss, or new steel or concrete caps to restore the upper portion of the timber piles. Per the as-built drawings, the dolphins are 16 inches in diameter and 50 feet long, and comprised of 112 individual piles.

Photo 4 - Typical timber dolphin and floating dock. Note fiberglass jacket and concrete cap on the piles.

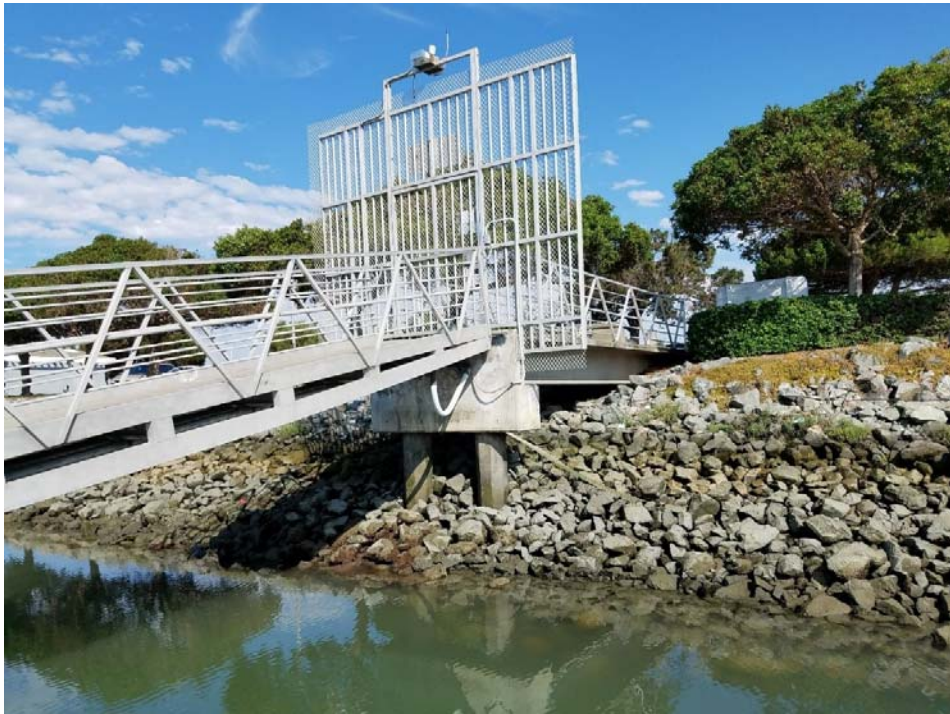
All ten gangways were replaced during the 1990 renovation and are 38-foot long aluminum structures. They appear to be in serviceable condition and without any noticeable deterioration or corrosion.

Photo 5 - Concrete Access Pier and Aluminum Gangway

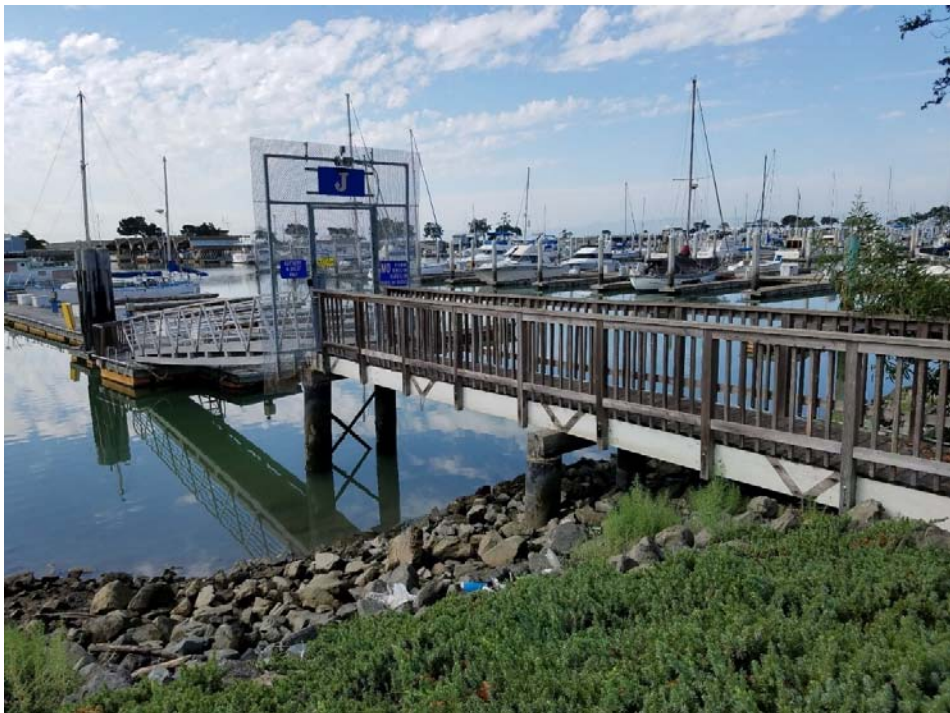
Photo 6 - Timber Access Pier and Aluminum Gangway

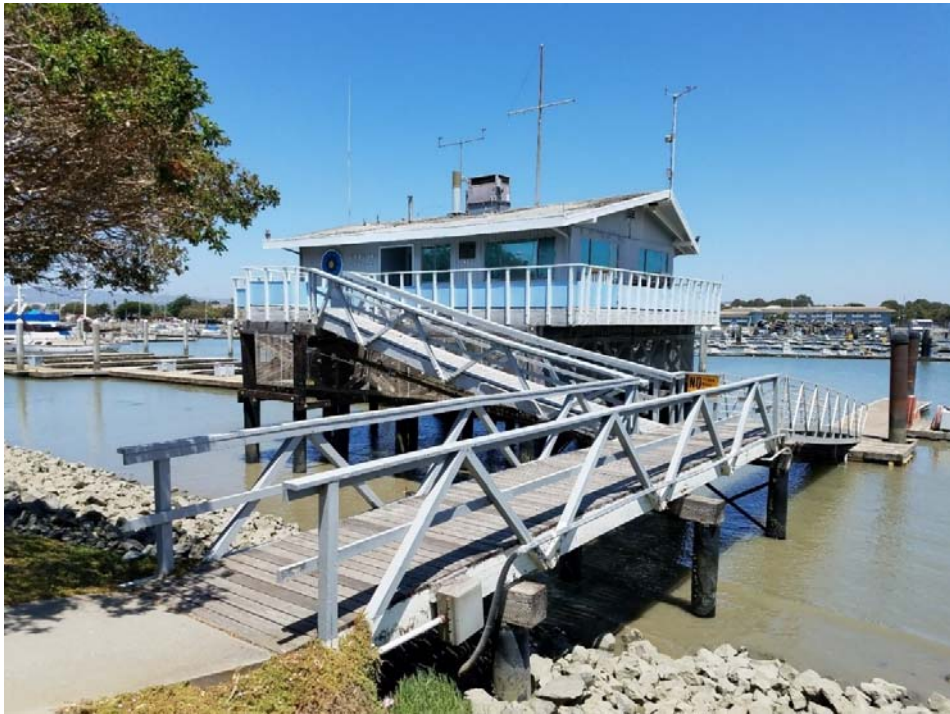
Sample PAINT-HM-1, collected from an exterior wall of the Harbor Master's office, also had an elevated concentration of lead (850 mg/kg). While this concentration is not above the DTSC Hazardous Waste threshold it could be representative of paint that was once primarily lead-based but was subsequently painted over.

Photo 7 - Harbor Master's Office and timber access ramp

GHD recommends that all painted wood removed from the Harbor Master's office, including the raised walkway between the parking lot and the main building, be disposed of as hazardous waste at an appropriately permitted disposal facility.

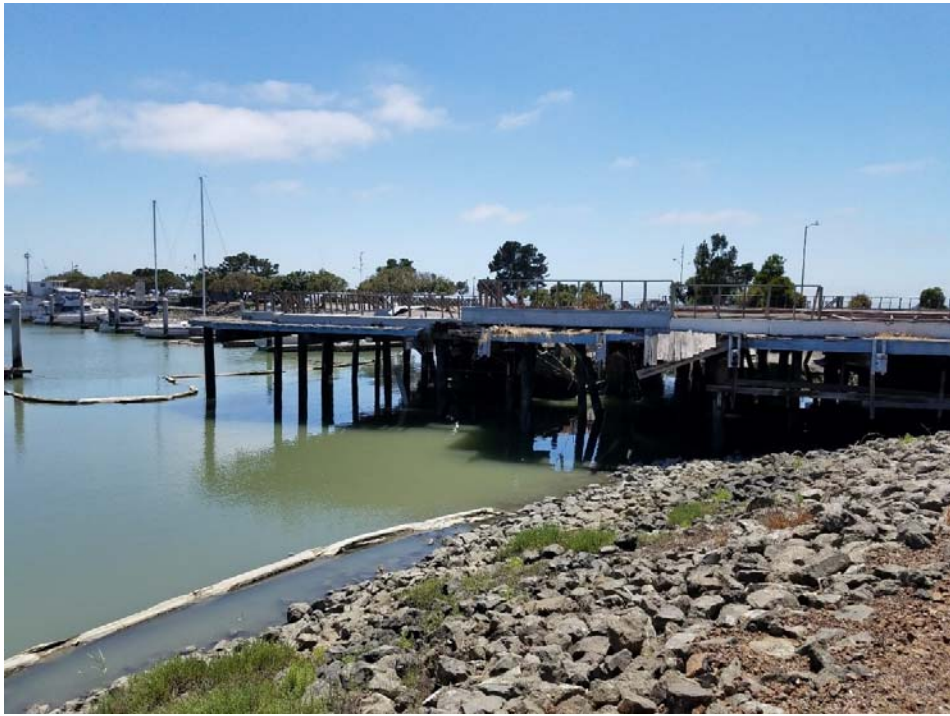
North of Pier A is what remains of the Blue Dolphin Restaurant. The previous building owner closed his business and left the building to rot and all that remains are the piles and pile-supported foundation. Due to the highly deteriorated state, it was not safe to inspect or quantify the piles.

The timber piles are not anticipated to be salvageable and due to deterioration it may be difficult to completely remove the piles without damage.

Photo 9 - Blue Dolphin Restaurant Foundation

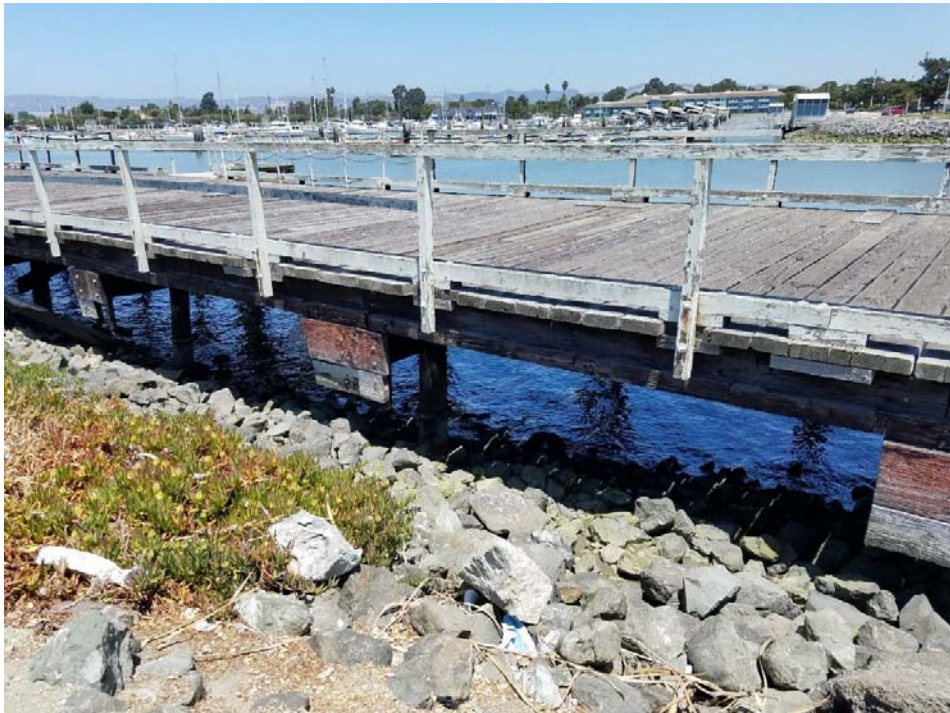
In addition, there are a two other structures supported by piles over the water, namely the Blue Dolphin Restaurant and a former observation deck (now closed), located north and south of Pier A, respectively. The observation deck was heavily damaged by fire, with only the foundation and piles still remaining.

Photo 10 - Closed Observation Deck

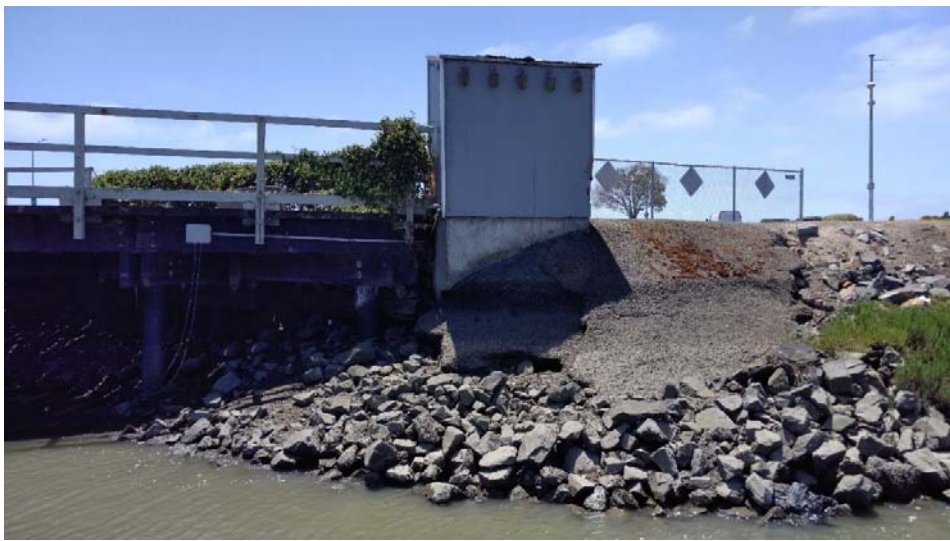
The refueling dock has been served by an on-shore plywood shed (approximately 6'L x 4'W x 8'H) containing electrical panels and pump controllers for pumps and tanks that no longer exist. The entire shed will be demolished to its foundation. The demolition shall include the removal of electrical panels, switches, light fixtures, controllers, and other related appurtenances, including the conduit and conductors attached to the outside and underside of the pile-supported deck.

Photo 14 - Plywood Shed and Pile-Supported Closed Observation Deck
