INITIAL SITE ASSESSMENT
ALTA MIRA CLUB
SOUTH PORCH WINDOW

561 LAFAYETTE AVE.
SAN LEANDRO, CA 94577

September 6, 2019

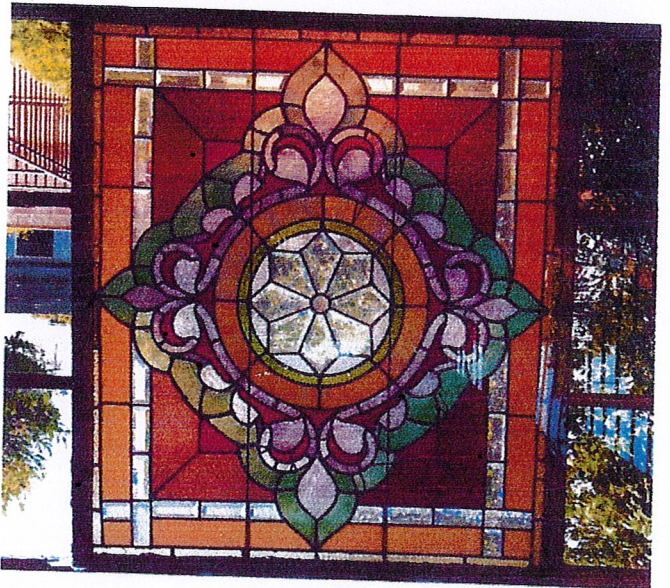
1 Before Treatment | overall of leaded art glass

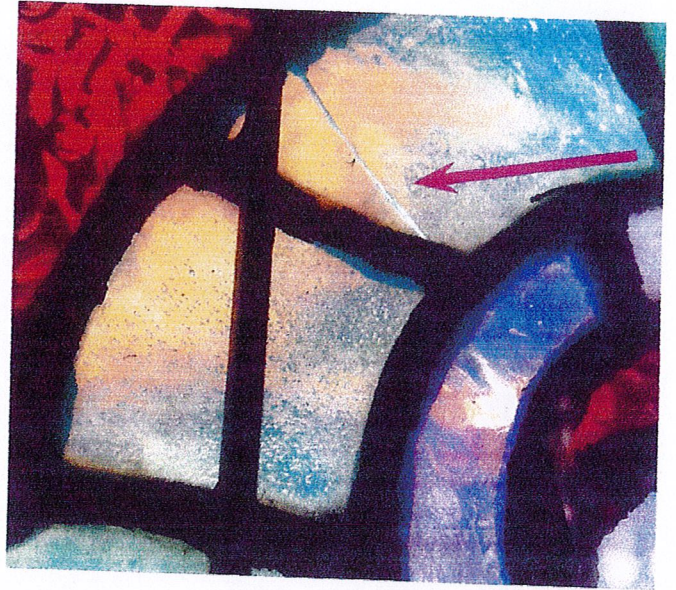
The art glass panel is in fair condition compared to the overall window. The majority is still flat and free from glass breakage. The right side border does have some bowing running the length of the panel, which has caused several breaks.

3 Before Treatment | detail of one of the many cracks in the art glass. Vertical steel support bar.

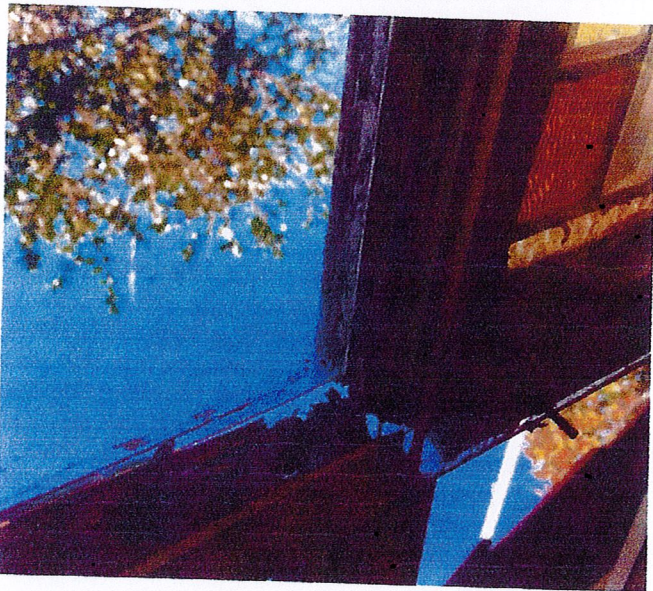
The wooden areas of the window are failing and are no longer sound. Localized sections of the wood muntins completely missing. This condition is most prevalent along the top of the art glass, which may have been accelerated by the incorrect installation of protective glazing. In these areas only the wood is black, soft and thoroughly rotten; due in part by lack of ventilation that prevented proper drainage and drying of rainwater. Any re-installation should therefore augment the protective glazing to allow proper drainage. Though the building is an historic landmark, the plexiglass was an addition with the intent to protect the leaded art glass from the public. Installed properly, this will extend the life of the window and the historic art glass in the center.

2 Before Treatment | wood loss caused by unskilled previous repair. Water was caught between plastic cover and art glass.

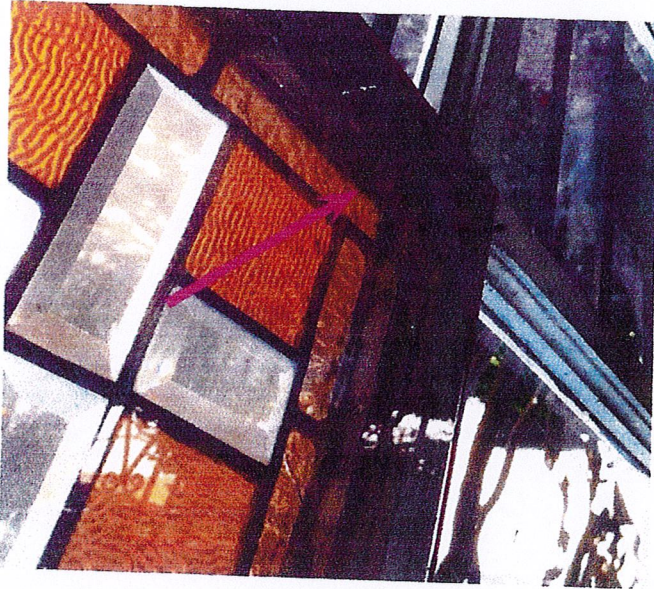
4 Before Treatment | putty trapped between the incorrectly installed plexiglass cover and the leaded art glass.
