INITIAL SITE ASSESSMENT
ALTA MIRA CLUB
SOUTH PORCH WINDOW

561 LAFAYETTE AVE.
SAN LEANDRO, CA 94577

September 6, 2019

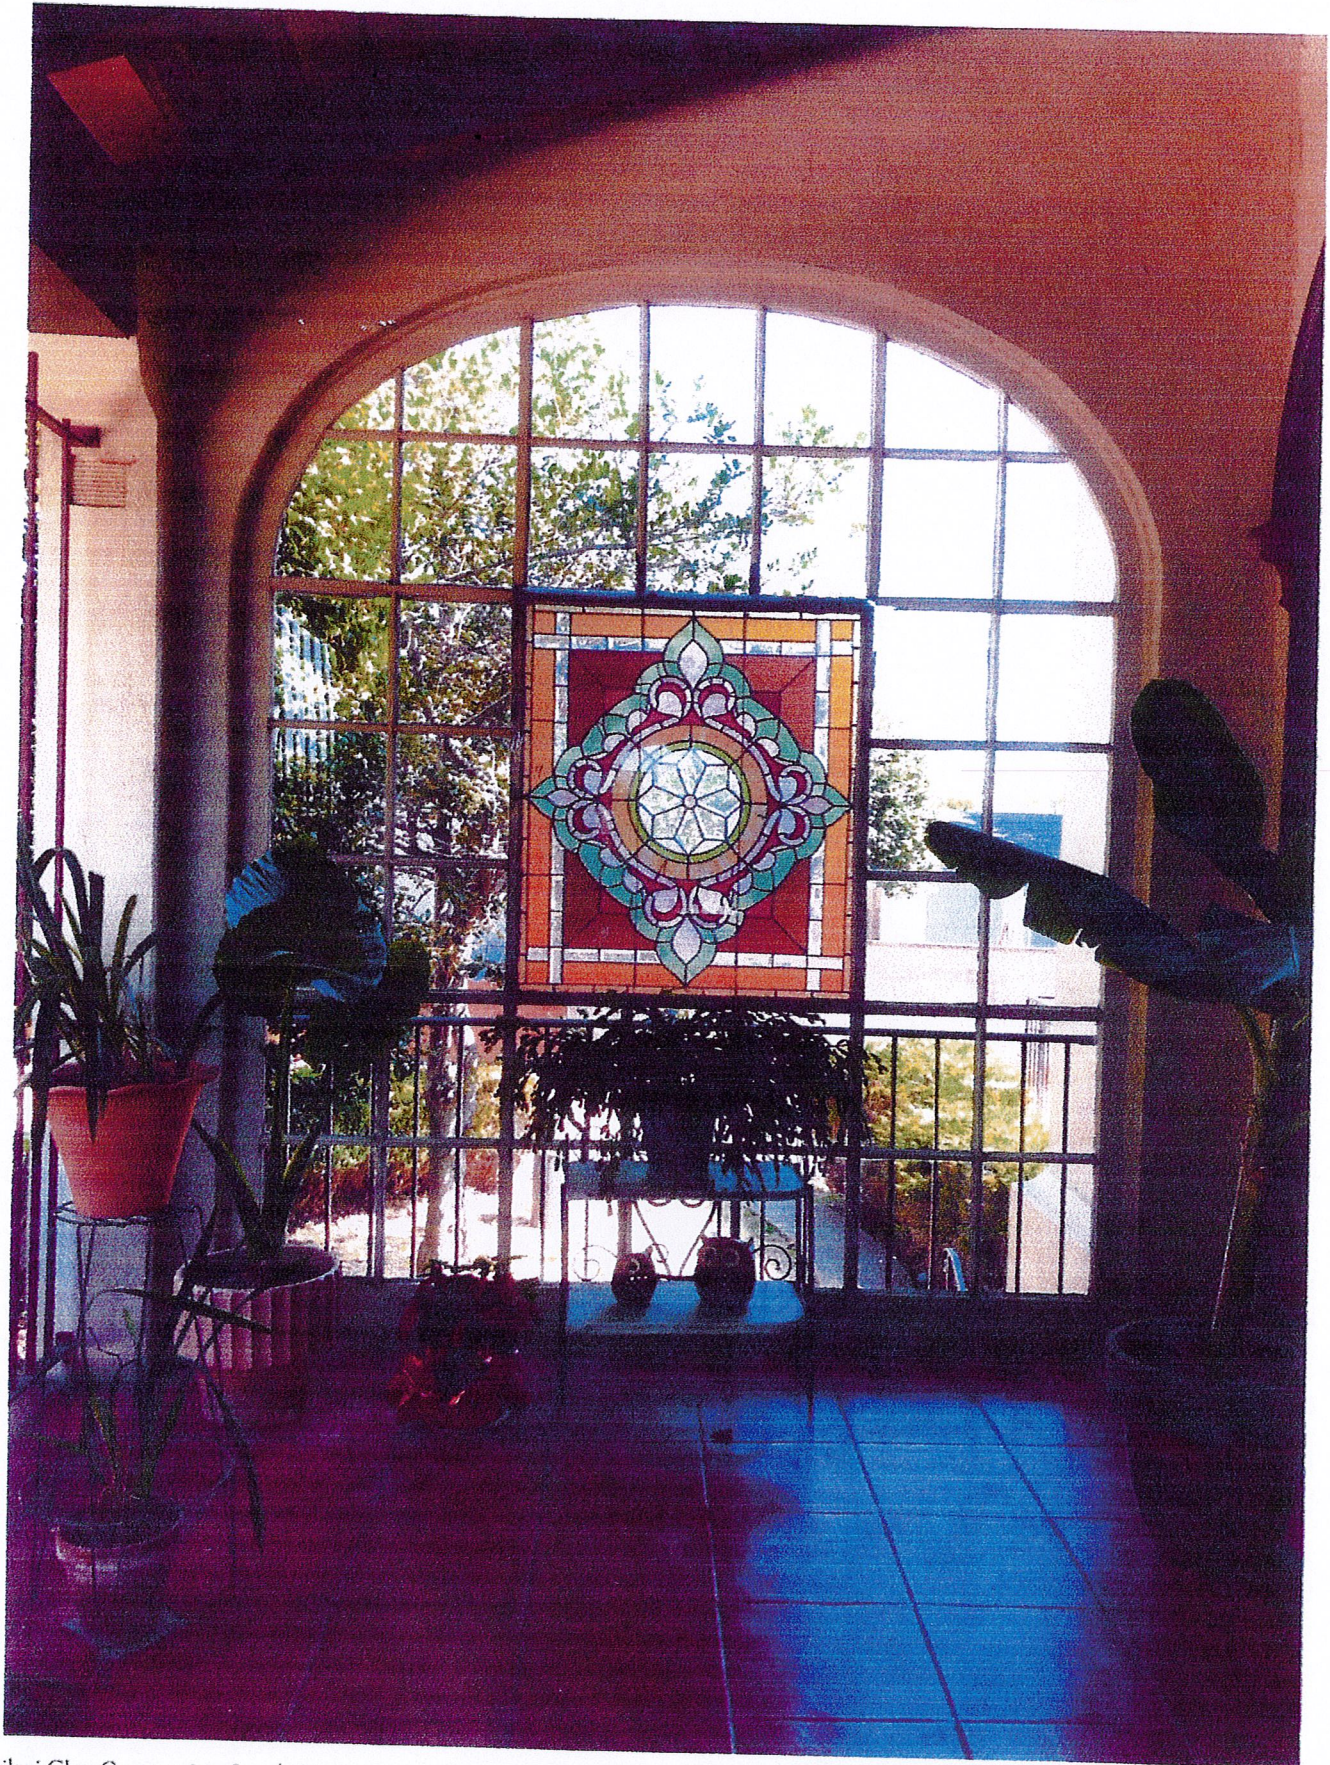
The wooden areas of the window are failing and are no longer sound. Localized sections of the wood muntins completely missing. This condition is most prevalent along the top of the art glass, which may have been accelerated by the incorrect installation of protective glazing. In these areas only the wood is black, soft and thoroughly rotten; due in part by lack of ventilation that prevented proper drainage and drying of rainwater. Any re-installation should therefore augment the protective glazing to allow proper drainage. Though the building is an historic landmark, the plexiglass was an addition with the intent to protect the leaded art glass from the public. Installed properly, this will extend the life of the window and the historic art glass in the center.

The entire window is structurally very unstable, and gives way to the tiniest amount of pressure applied by hand or strong wind. It is in extreme danger of collapse from wind/weather, or if pushed/fallen into by a person. And incident would completely collapse this area and would damage the art glass, which currently is salvageable. Though the Secretary of the Interior's Standards for (Historic) Preservation note replacing like for like, we propose replacing all the clear glass light sections with tempered glass since this frame is over an actively stairway and on a porch which is used for public events.

The art glass panel is in fair condition compared to the overall window. The majority is still flat and free from glass breakage. The right side border does have some bowing running the length of the panel, which has caused several breaks.
