U.S. Depart	ment	of Transportatio	n DAF No. L	.TP -	SLN	- 0	0 1 - 1 4				
Federal Hig	ghway	Administration	Sheet # 1 of	2 Federa	al Project # EO	ER - 15	5J7 (179)				
Damage As	ia Div	ision- Title 23 ient Form (DAF) Disaster No. CA	2 3 -	1 PR	ER - 15	5J7 (179)				
cant Other f O	1	va dua	County Alameda		Incident Date	e (mm/dd/yyy	y) Inspection				
City of S	an Lea	inaro	Congressional districts 1	4	/2022	12/31/2022					
ion of Damag	ge:		Per Site or	Per Mile	Federal-aid Highway?						
ne of Road/Br	idge:	Lake Chabot Roa	d		Y for yes, if no, ineligible for ER funds Y						
PM Begin:	200' e	ast of Chabot Ter	race PM L	ength: 1,500.00	Map No 5L34						
PM End:	1700'	east of Chabot Te	errace	(in feet)	Functional Classification Type:						
Bridge	Bri	dge	Type:		Minor Arteria Route	al #					
aveled Way.] W	idth 28 ft		Gravel	Forest Hww		Interstate? V/N N				
Shoulder:	W	idth 2 ft	Type: PCC AC	Gravel	Existing	ADT: 3,521

DAF # LTP - SLN	_ 0 0 1 _ 1	
U.S. Department of Transportation Federal Highway Administration- California Division- Title 23 Damage Assessment Form (DAF)	Sheet # 3 Applicant City of San Leandro	of <u>12</u>	
Photo	s, Sketches and/or Narrative

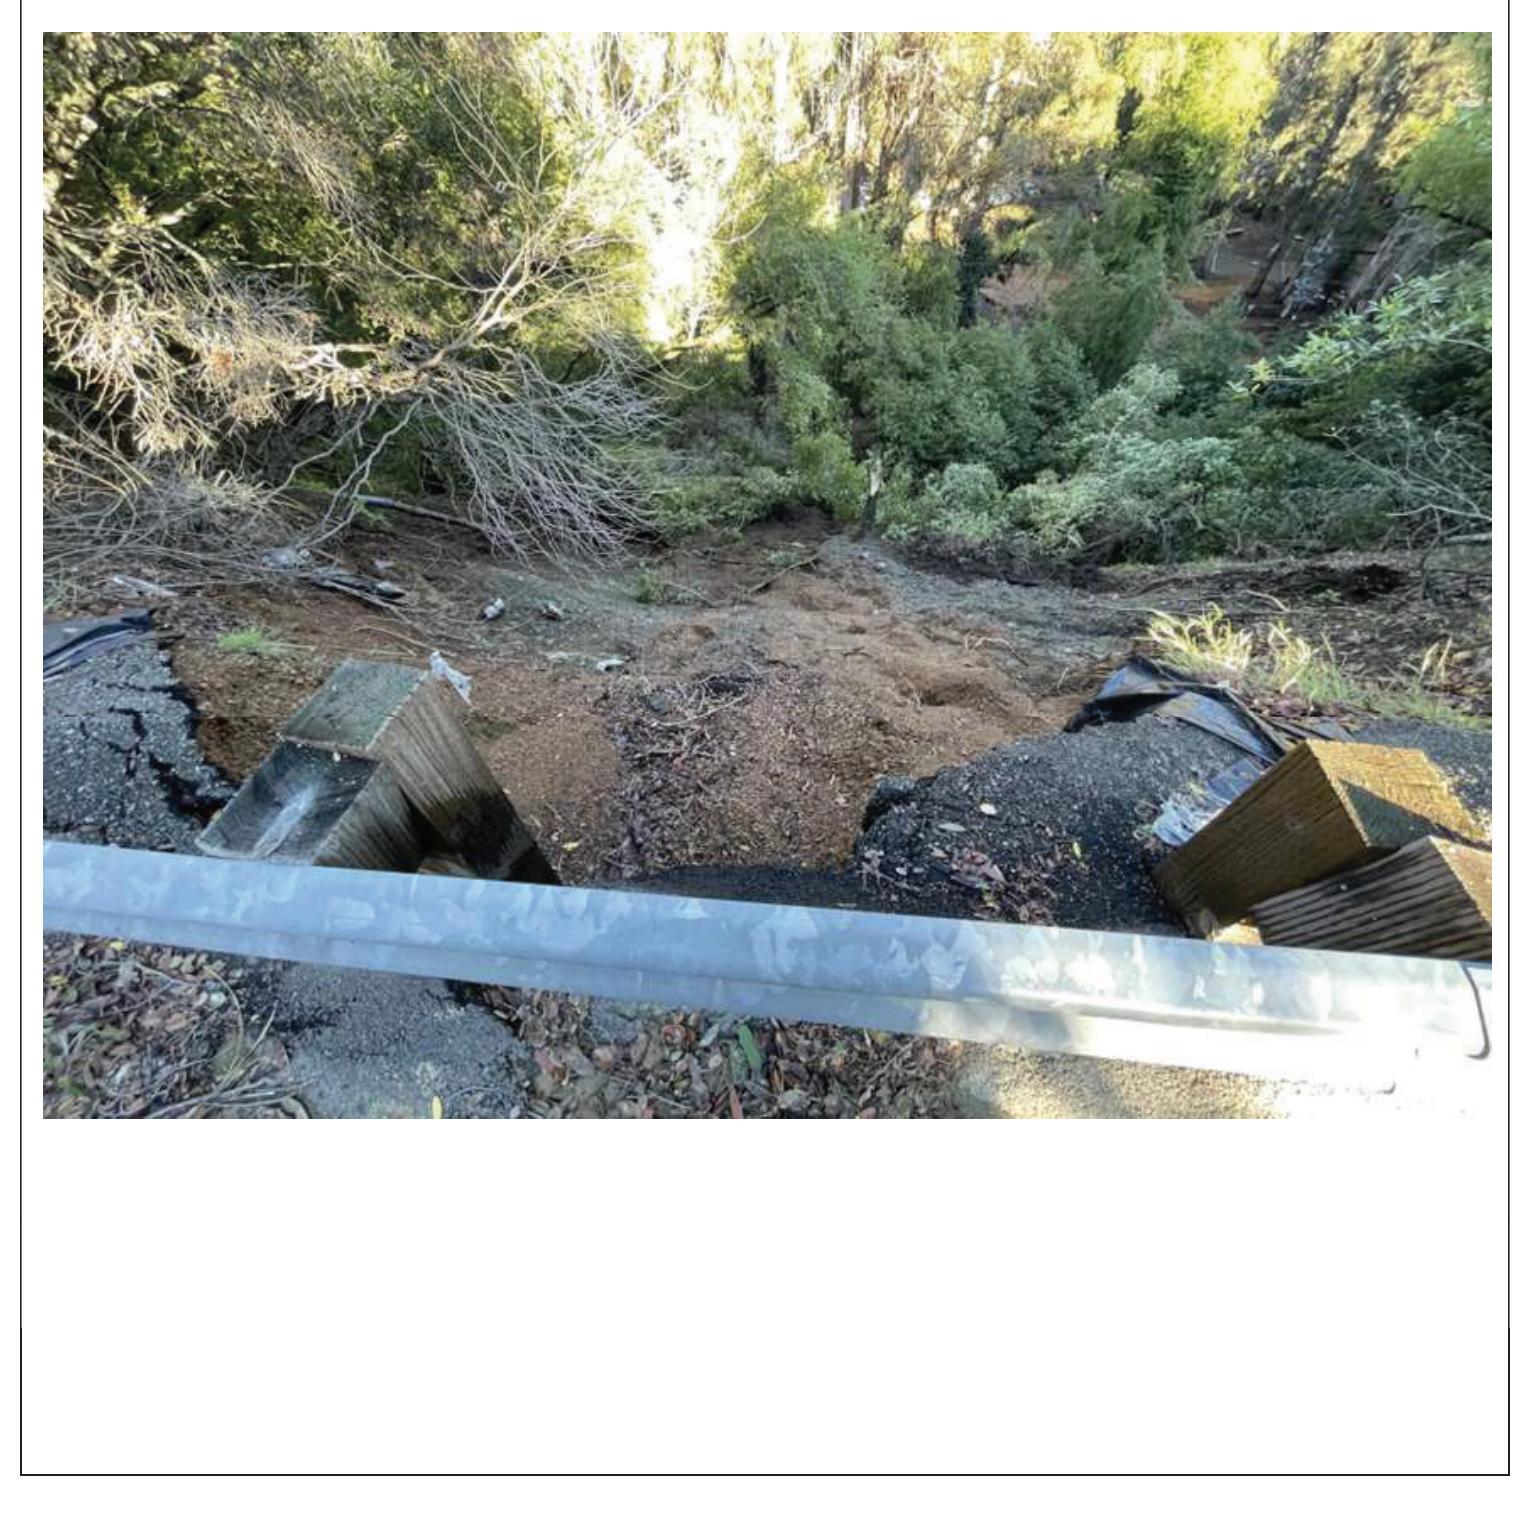
Site A: Downslope failed. Geotechnical engineer says support under pavement is lost to midpoint of westbound Photo description: lane.

This repair method will be staged and constructed from the above roadway and will not require any access or easements to the adjacent downslope private property. The hillside below the newly constructed retaining structure will remain in its current condition and with minimal environmental impact to the creek below.
