## Historic Evaluation of 1919 Williams Street

San Leandro, CA 94577

April 2021

MacRostie Historic Advisors LLC

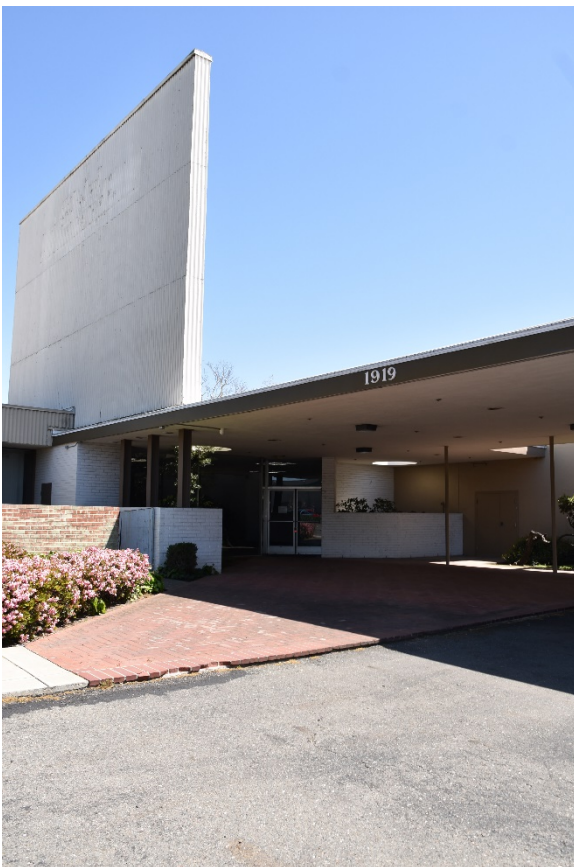
Photo 1: Main entry of 1919 Williams Street.

The building's main entry is at the west side of the T-shaped plan, where the building's north, south, and east wings meet and is topped by a large, corrugated metal clad blade sign that rises from the roof and originally held the building's signage. The entry has a paved brick sidewalk and is topped by a flat canopy that continues westward to provide covered parking beneath. The west side of the canopy has exposed I-beam supports that extend to a brick planter on the north side of the entry. The south side of the entry is also flanked with a semi-circular planter. The awning above each planter has a circular cut-out for light and to allow plantings to extend above the roofline. The main entry has a large storefront window with a fully-glazed paired door with a transom above.

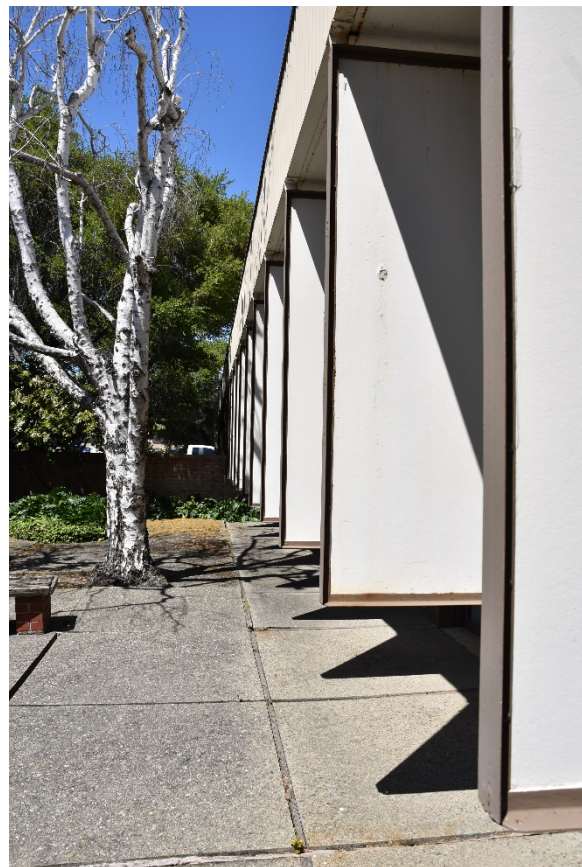
Photo 2: West elevation of fin details at the building's north wing.

The west elevation, facing the parking lot, extends north toward Williams Street. It is 23 bays and features a flat roof with a corrugated metal-faced eave. Each bay and is separated by the next with a decorative metal frame-wood fin blade detail that extends from the eave of the flat roof overhang. The southern bays are separated by the northern bays by a short brick wall with a gate, thereby creating a courtyard at the southern end of the elevation. Windows at these bays are full-height. The remainder,

northern bays, have large windows with wood spandrel panels below. The courtyard portion of the elevation has pavers with a semi-circular bench and a planted portion.

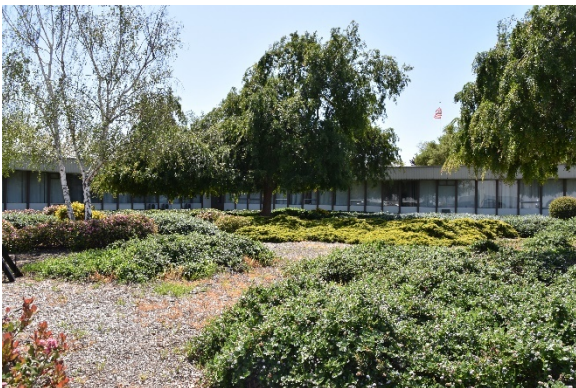
Photo 3: East elevation of north wing and north wing of east elevation.

The building's Williams and Merced Streets elevation is comprised of the east elevation of the north wing and the north elevation of the east wing. The east elevation also extends for 23 bays. Each bay has a large window with a wood spandrel panel below. Some windows contain an operable hopper casement window above the spandrel. The north elevation extends to the sidewalk and repeats the same pattern. The space between the two elevations is open and features a planted landscape with ornamental trees, shrubs, and flowers.

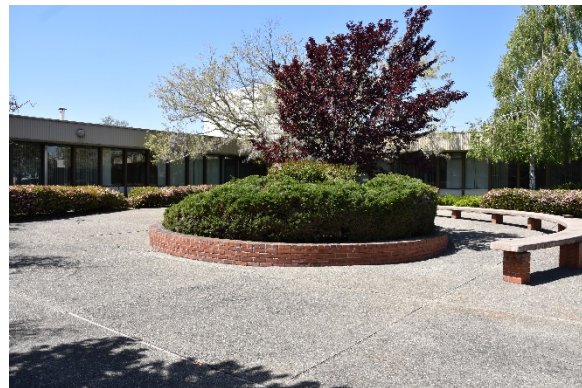
Photo 4: South elevation of east wing and east elevation of south wing from building courtyard

The remainder of the office portion of the building is comprised of the east elevation of the south wing and the south elevation of the east wing and is only accessible from the building's interior. The east and south elevation feature the same configuration as other elevations and feature large windows at each bay with spandrel wood panels below. The elevations front a private employee courtyard. The courtyard has a paved surface with square brick planters planted with trees at the south end. The center of the courtyard is punctuated with a circular brick planter planted with shrubs and trees with a large, semicircular bench along its north end. There is a modern, non-historic shed structure at the east of the center planter that appears to have most recently served as a designated employee smoking area.

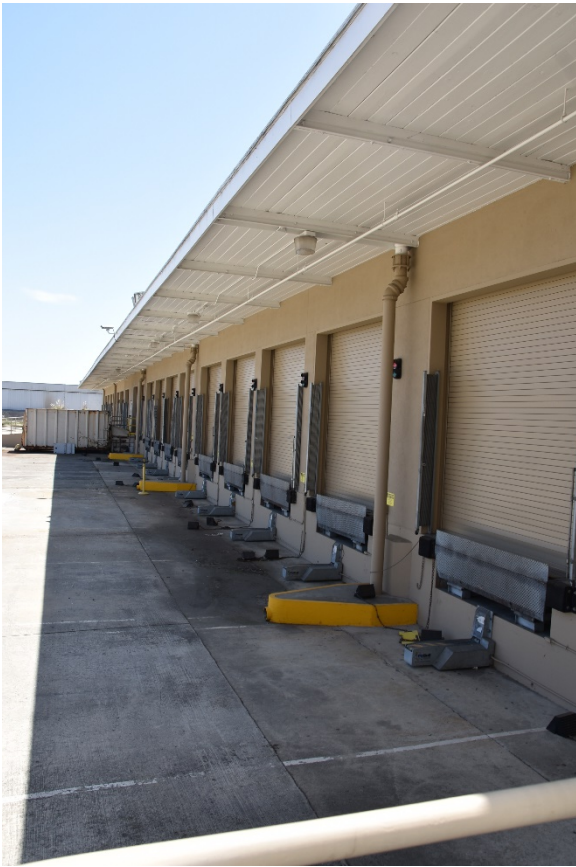
Picture 7: Warehouse loading doors at east elevation

The building's warehouse is to the south and west of the office portion of the building and is comprised of four portions constructed over time. The east elevation is comprised of the original 1952 portion and a portion the c. 1985 addition and continues for 20 bays. Each bay features a loading dock with a roll-up door. A sloped ramp south of the center bay at this elevation marks the original building from the later addition. A metal awning tops each of the loading dock entries. The roofline of the c. 1985 addition rises above the original roofline to the north.

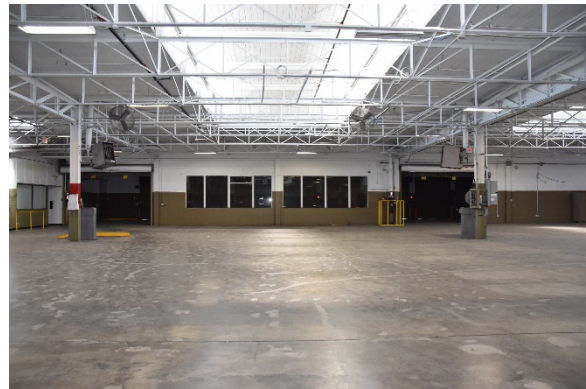
Picture 8: Warehouse interior, monitor roof above

The warehouse building has a flat roof. The original 1952 portion of the building features 10 monitors, providing natural light to the warehouse within.

The warehouse interior is characterized by its expansive open space, high ceilings, and concrete floors. The original warehouse portion has an exposed steel trusses and monitors with glazing above, allowing natural light into the building. Generally, there are few interior partitions and are limited to those between building additions.

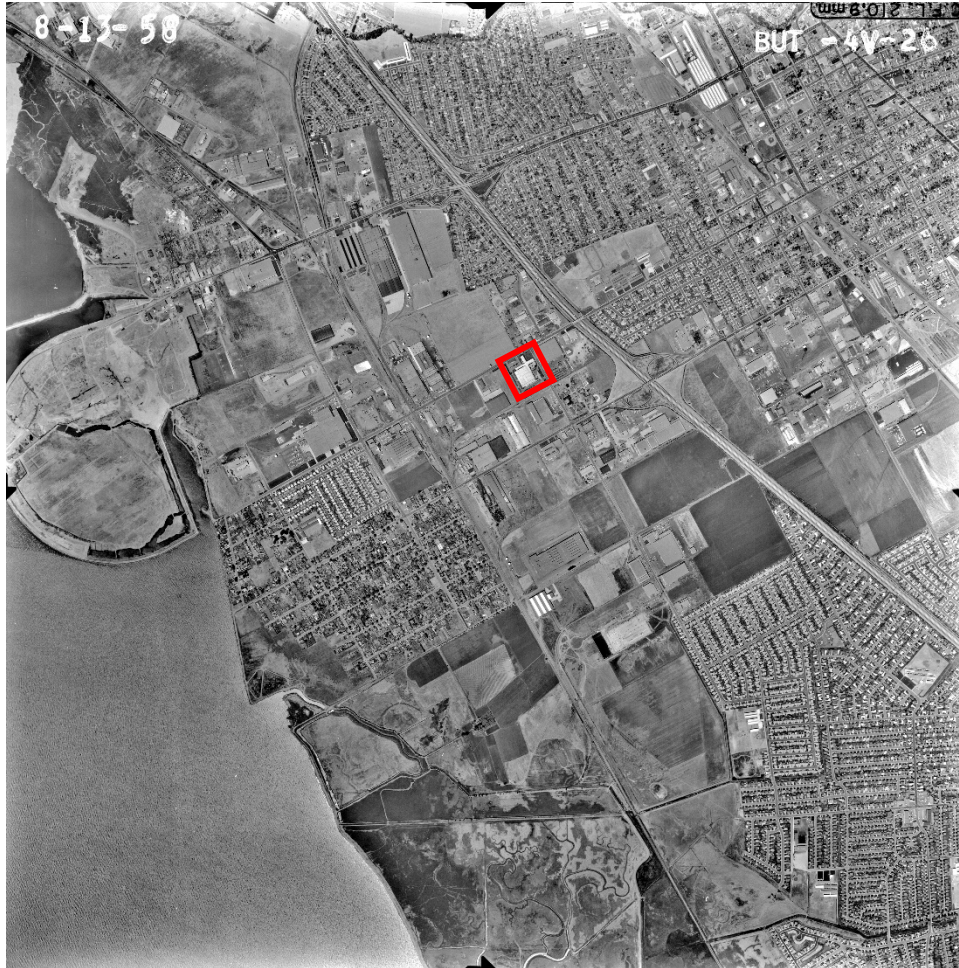
Figure 2: 1959 aerial of San Leandro  
Source: UC Santa Barbara

The 10-acre site originally included a 72,000 square foot warehouse and the 10,000 square foot cruciform office plan. In 1963 the facility was expanded with an adjoining warehouse to accommodate the Kilsby Tube Supply, an independent division of the Republic Supply Company.<sup>15</sup> The building was sold in 1966 to JI Case Co, a manufacturer of construction and agricultural equipment.<sup>16</sup> It was most recently occupied by CNH America, who also manufactures large agricultural equipment. The building received two additions – the warehouse was extended on its western end in 1982. The building received
